New Hampshire Volunteer Lake Assessment Program

2003 Interim Report for Mascoma Lake Enfield

NHDES
Water Division
Watershed Management Bureau
29 Hazen Drive
Concord, NH 03301

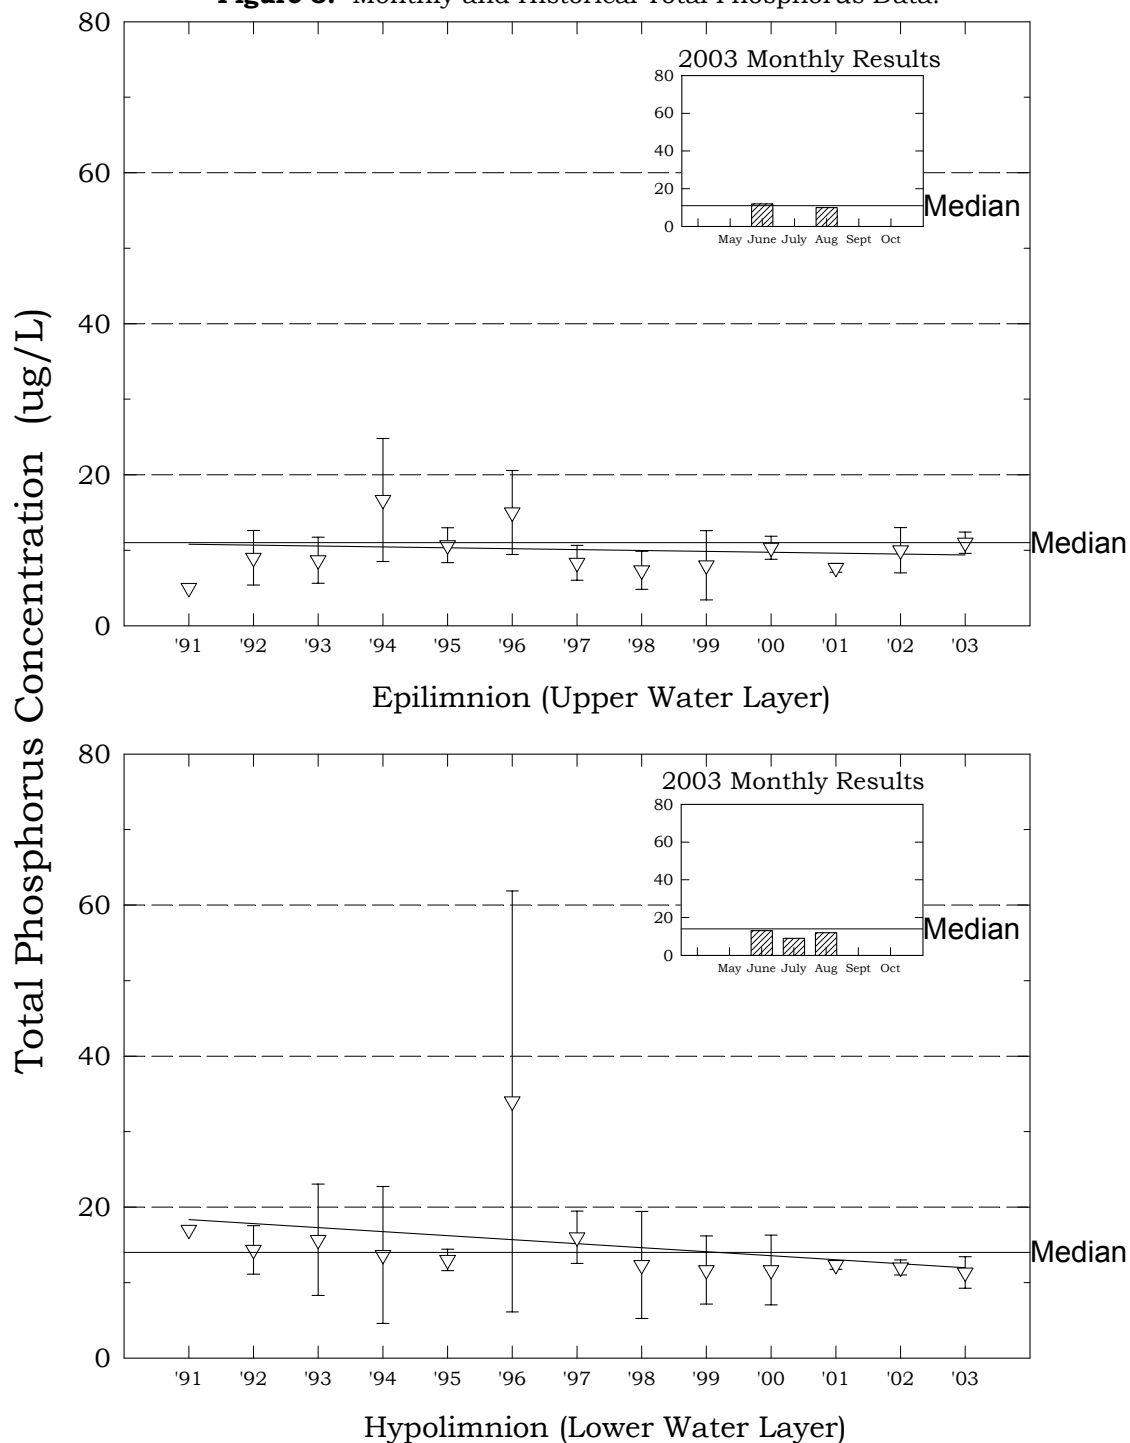
Figure 3. Monthly and Historical Total Phosphorus Data.

STATION 2: The current year data for the epilimnion (the top inset graph) show that the phosphorus concentration ***remained stable*** from June to and August. (Due to a problem with sample bottle labels on the July sampling event, there was no phosphorus result for the July epilimnion sample.)

The historical data show that the 2003 mean epilimnetic phosphorus concentration is ***approximately equal to*** the state median.

The current year data for the hypolimnion (the bottom inset graph) show that the phosphorus concentration ***decreased slightly*** from June to July, and then ***increased*** from July to August.

The historical data show that the 2003 mean hypolimnetic phosphorus concentration is ***slightly less than*** the state median.

Overall, visual inspection of the historical data trend line for the epilimnion and hypolimnion show ***a variable, but overall stable*** phosphorus trend. This means that the phosphorus concentration has ***fluctuated*** but has *not continually increased or continually decreased* at this station since monitoring began.

- **Figure 3 and Table 8:** The graphs in Figure 3 (Appendix A) show the amounts of phosphorus in the epilimnion (the upper layer) and the hypolimnion (the lower layer); the inset graphs show current year data. Table 8 (Appendix B) lists the annual maximum, minimum, and median concentration for each deep spot layer and each tributary since the lake/pond has joined the program.
